# Manhole Inspection Summary

Manhole # S09QQ\_046MH

Insp Date: **7/17/09 11:15 AM**

**Location** Address: **3208 VICKERS RD**

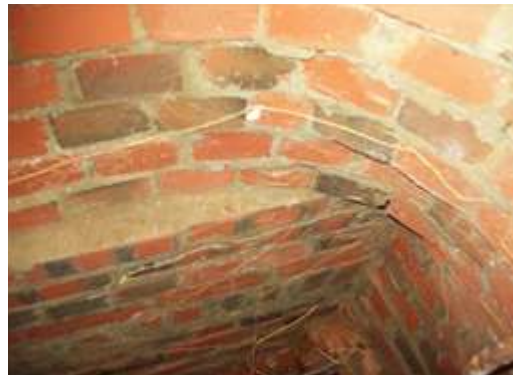
Defect 1

Condition: ☐ Sound ☐ Cracked ☒ **Root Intrusion** ☐ Loose Brick ☐ Deteriorated

Infiltration: ☐ None ☐ Joint ☐ Cracks ☐ Mortar ☒ **Roots** ☐ Wall

ROOTS IN CORBEL

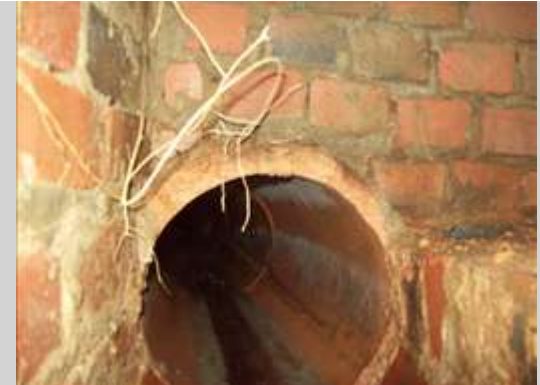
12 O'Clock Outflow

8 in. Circular Gravity Sewer  
Pipe Out @ 12 O'Clock

Pipe Material: **Clay** ☐ Pipe Lined

Invert Depth: **5.40** (ft.) Flow Characteristics: **Slow**

Infiltration: **None** Pipe Seal Cond: **Sound**

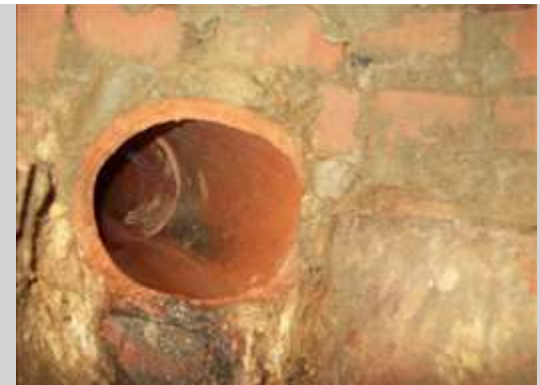
4 O'Clock Inflow

8 in. Circular Gravity Sewer  
Pipe In @ 4 O'Clock

Pipe Material: **Clay** ☐ Pipe Lined

Invert Depth: **5.20** (ft.) Flow Characteristics: **None**

Infiltration: **None** Pipe Seal Cond: **Sound**

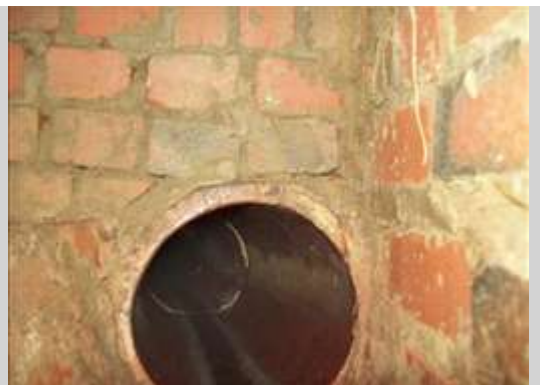
6 O'Clock Inflow

8 in. Circular Gravity Sewer  
Pipe In @ 6 O'Clock

Pipe Material: **Clay** ☐ Pipe Lined

Invert Depth: **5.60** (ft.) Flow Characteristics: **Slow**

Infiltration: **None** Pipe Seal Cond: **Sound**
